# TECHNICAL INSPECTION REPORT

U.S.S. PENSACOLA (CA24)

TEST ABLE

OPERATION CROSSROADS

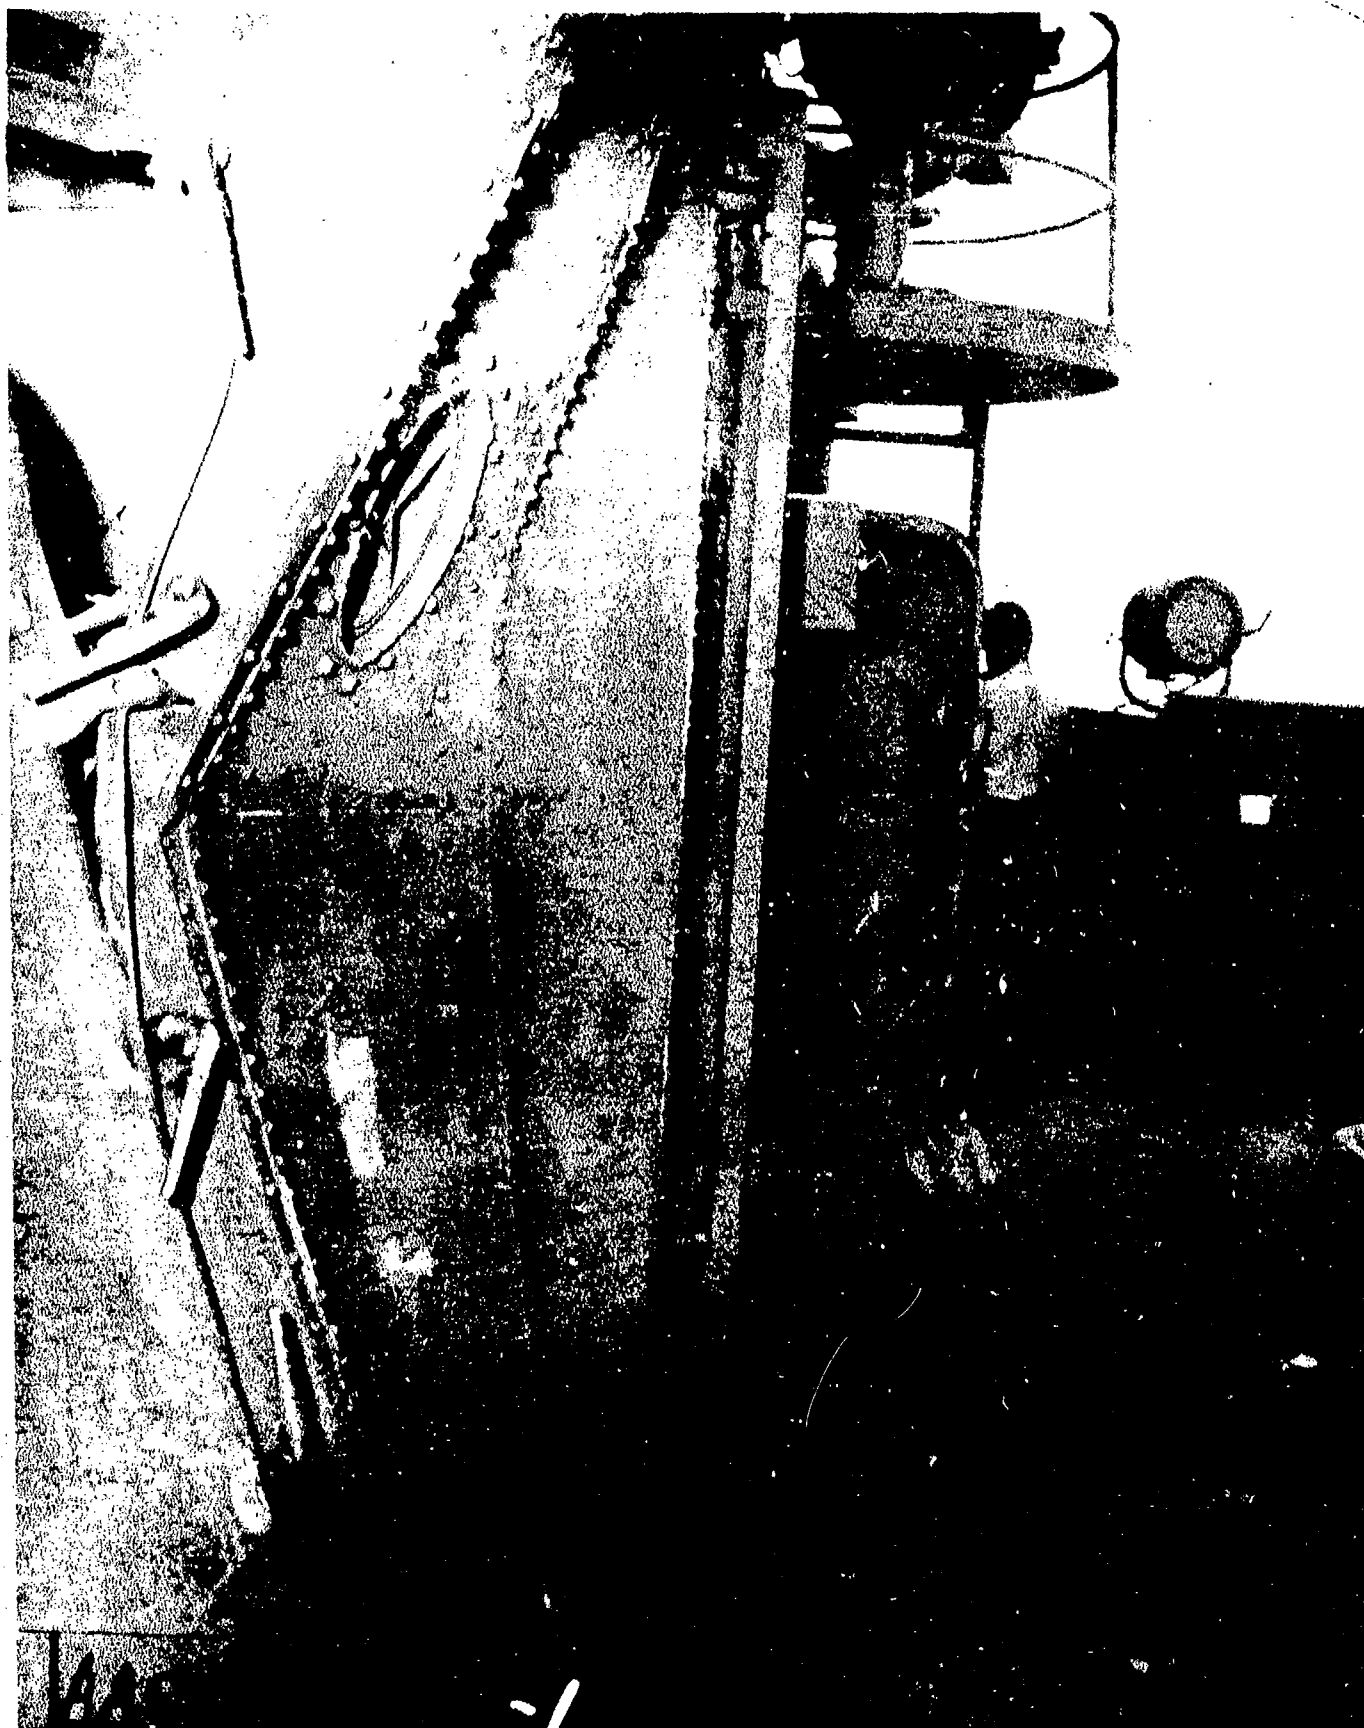
AA-CR-68-1761-1. Looking forward on starboard side of navigating bridge showing damage to aluminum deck house.

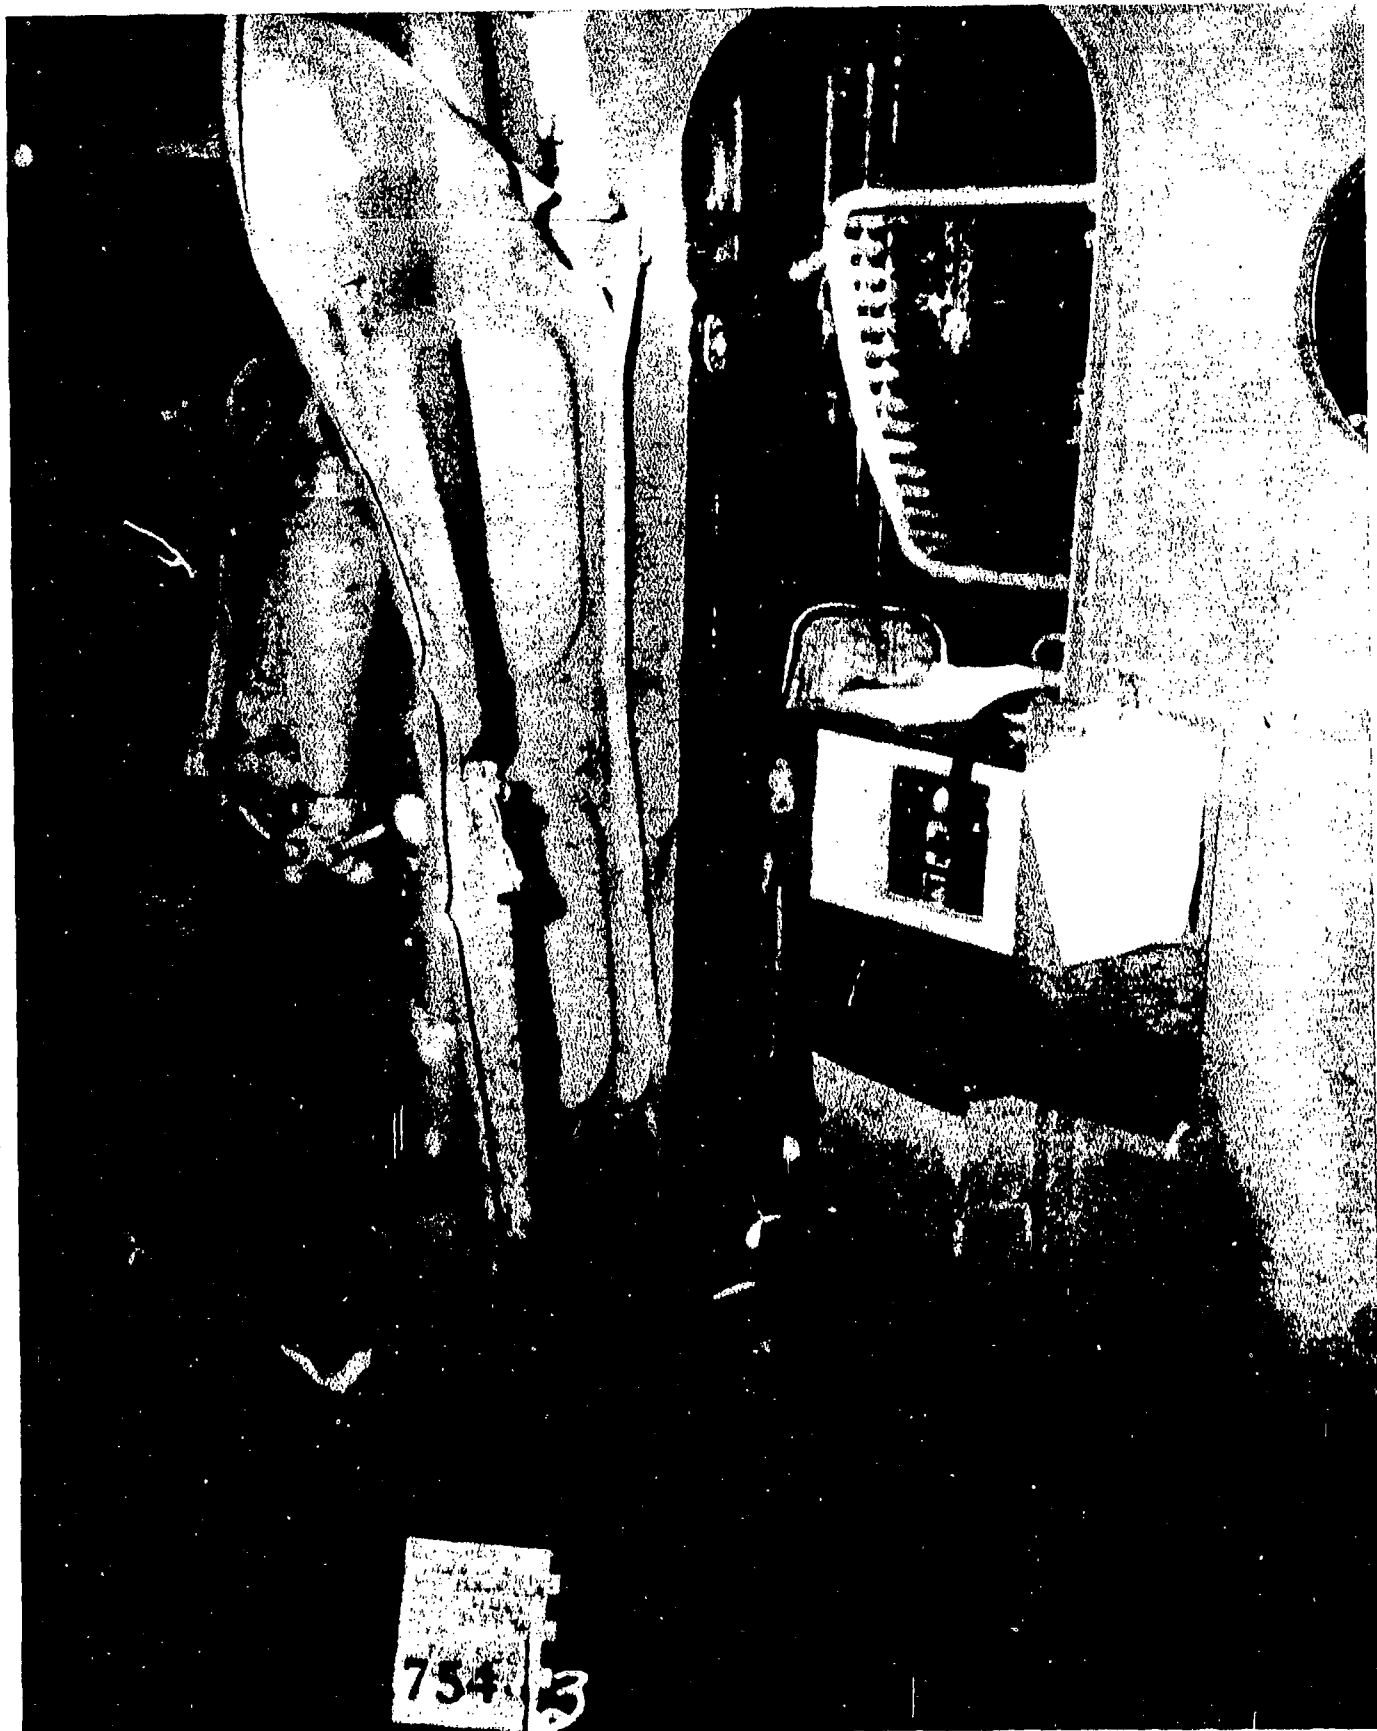
AA-CR-68-1754-3. Damage to door in bulkhead 49 on port side of main deck looking aft and to starboard.

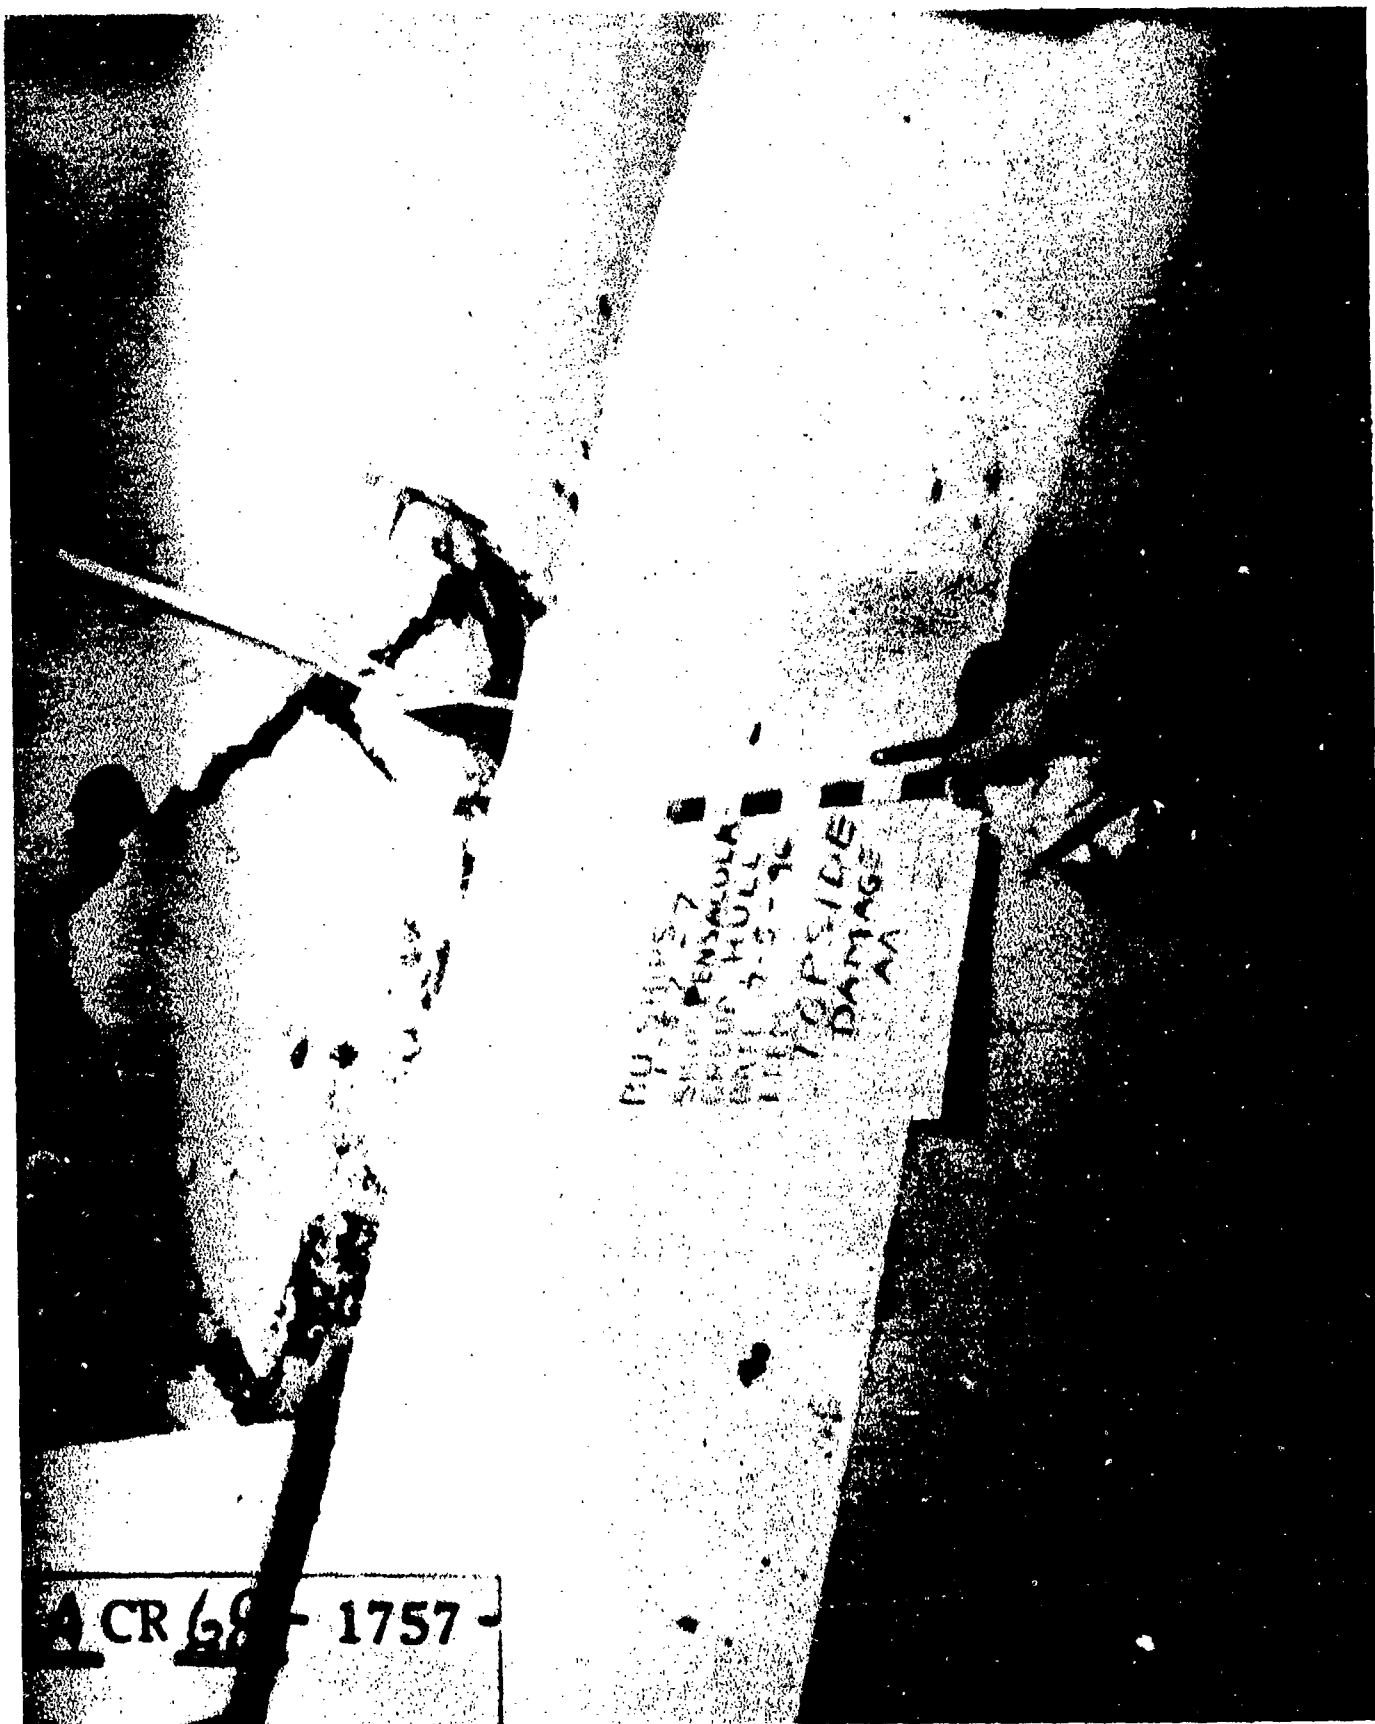
AA-CR-68-1757-7. Looking upward and aft at underside of superstructure deck in way of damage to starboard mainmast strut.

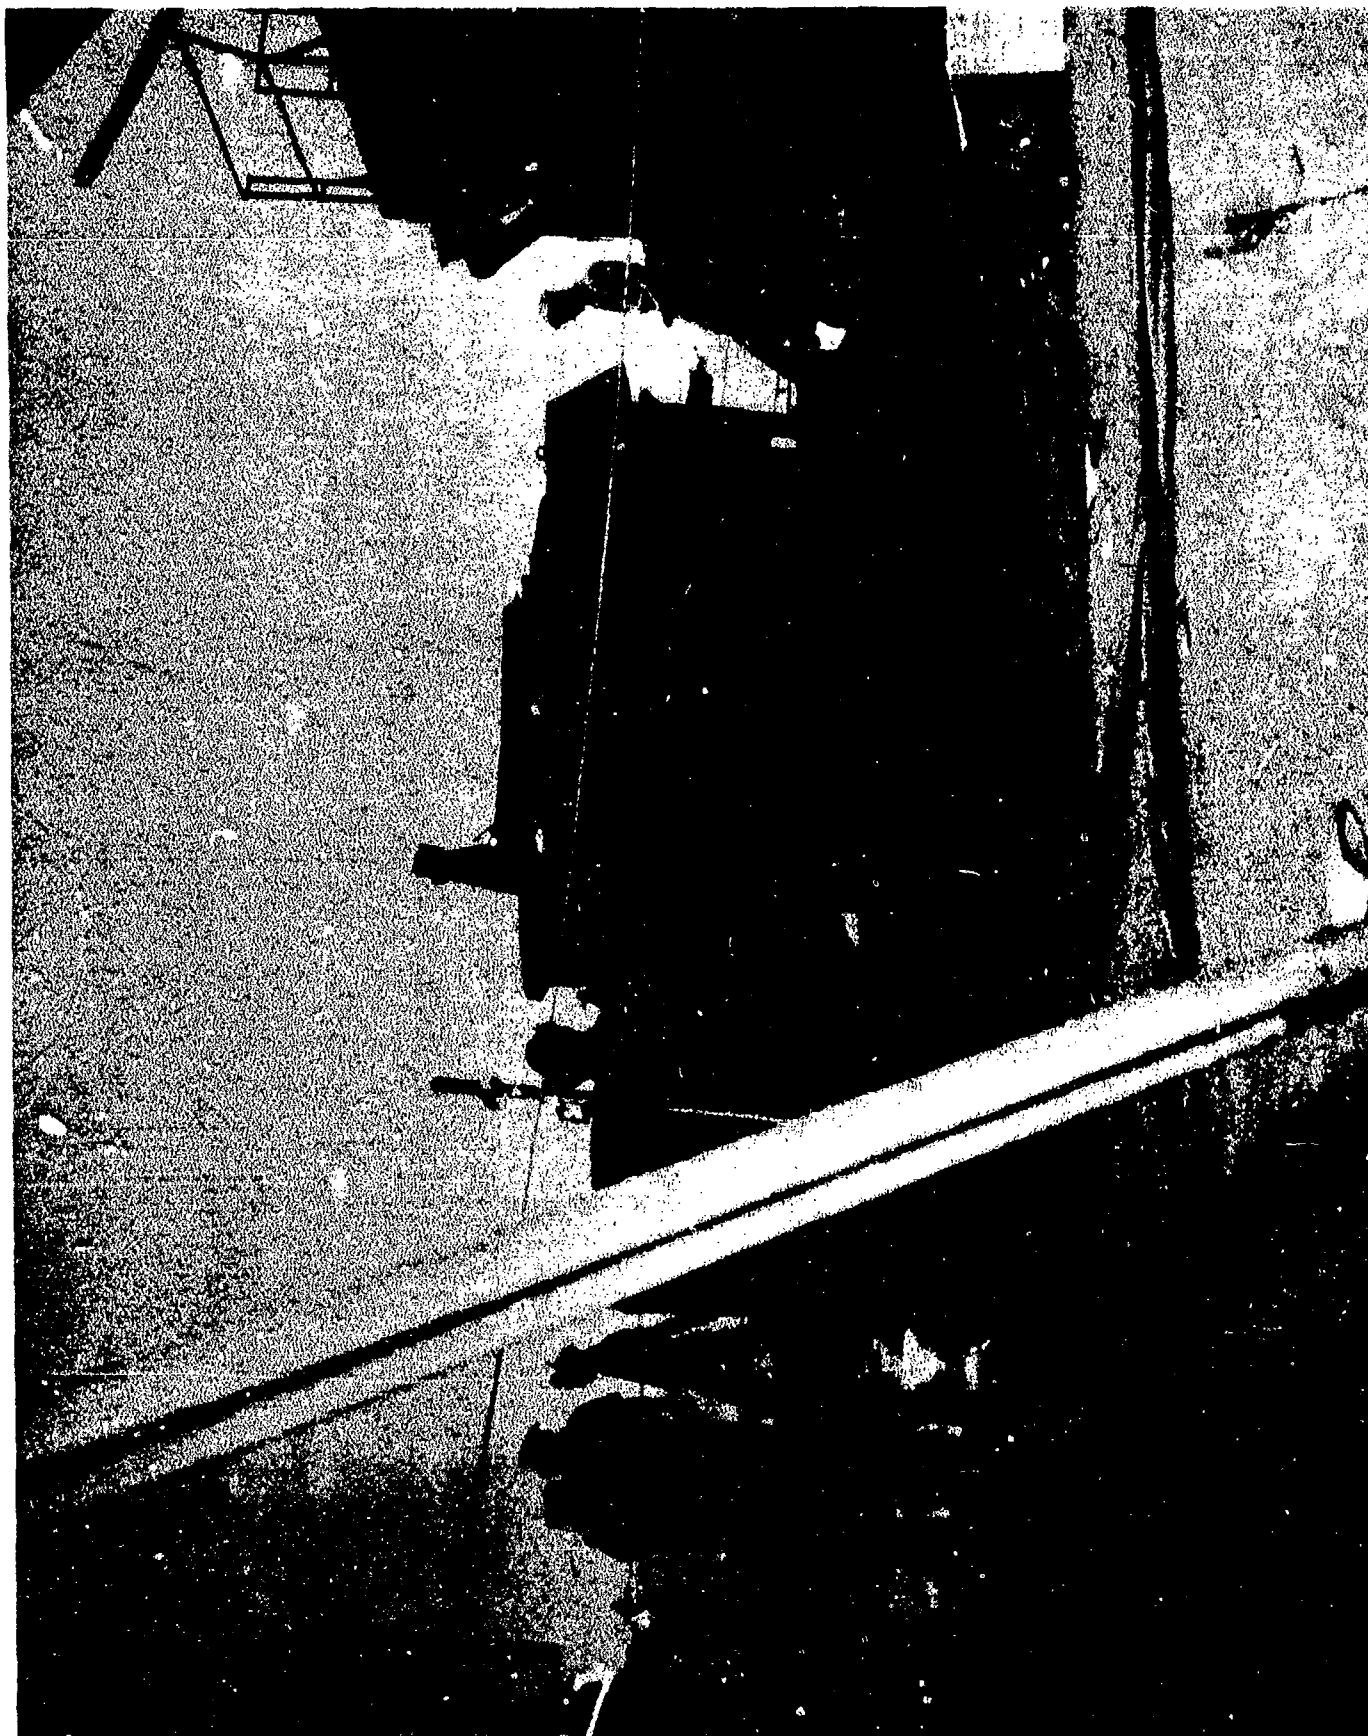
AA-CR-68-1767-7. Looking to port from starboard deck edge in main deck, well deck area showing area of severe dishing, also plate failure along edge of starboard stringer strake.

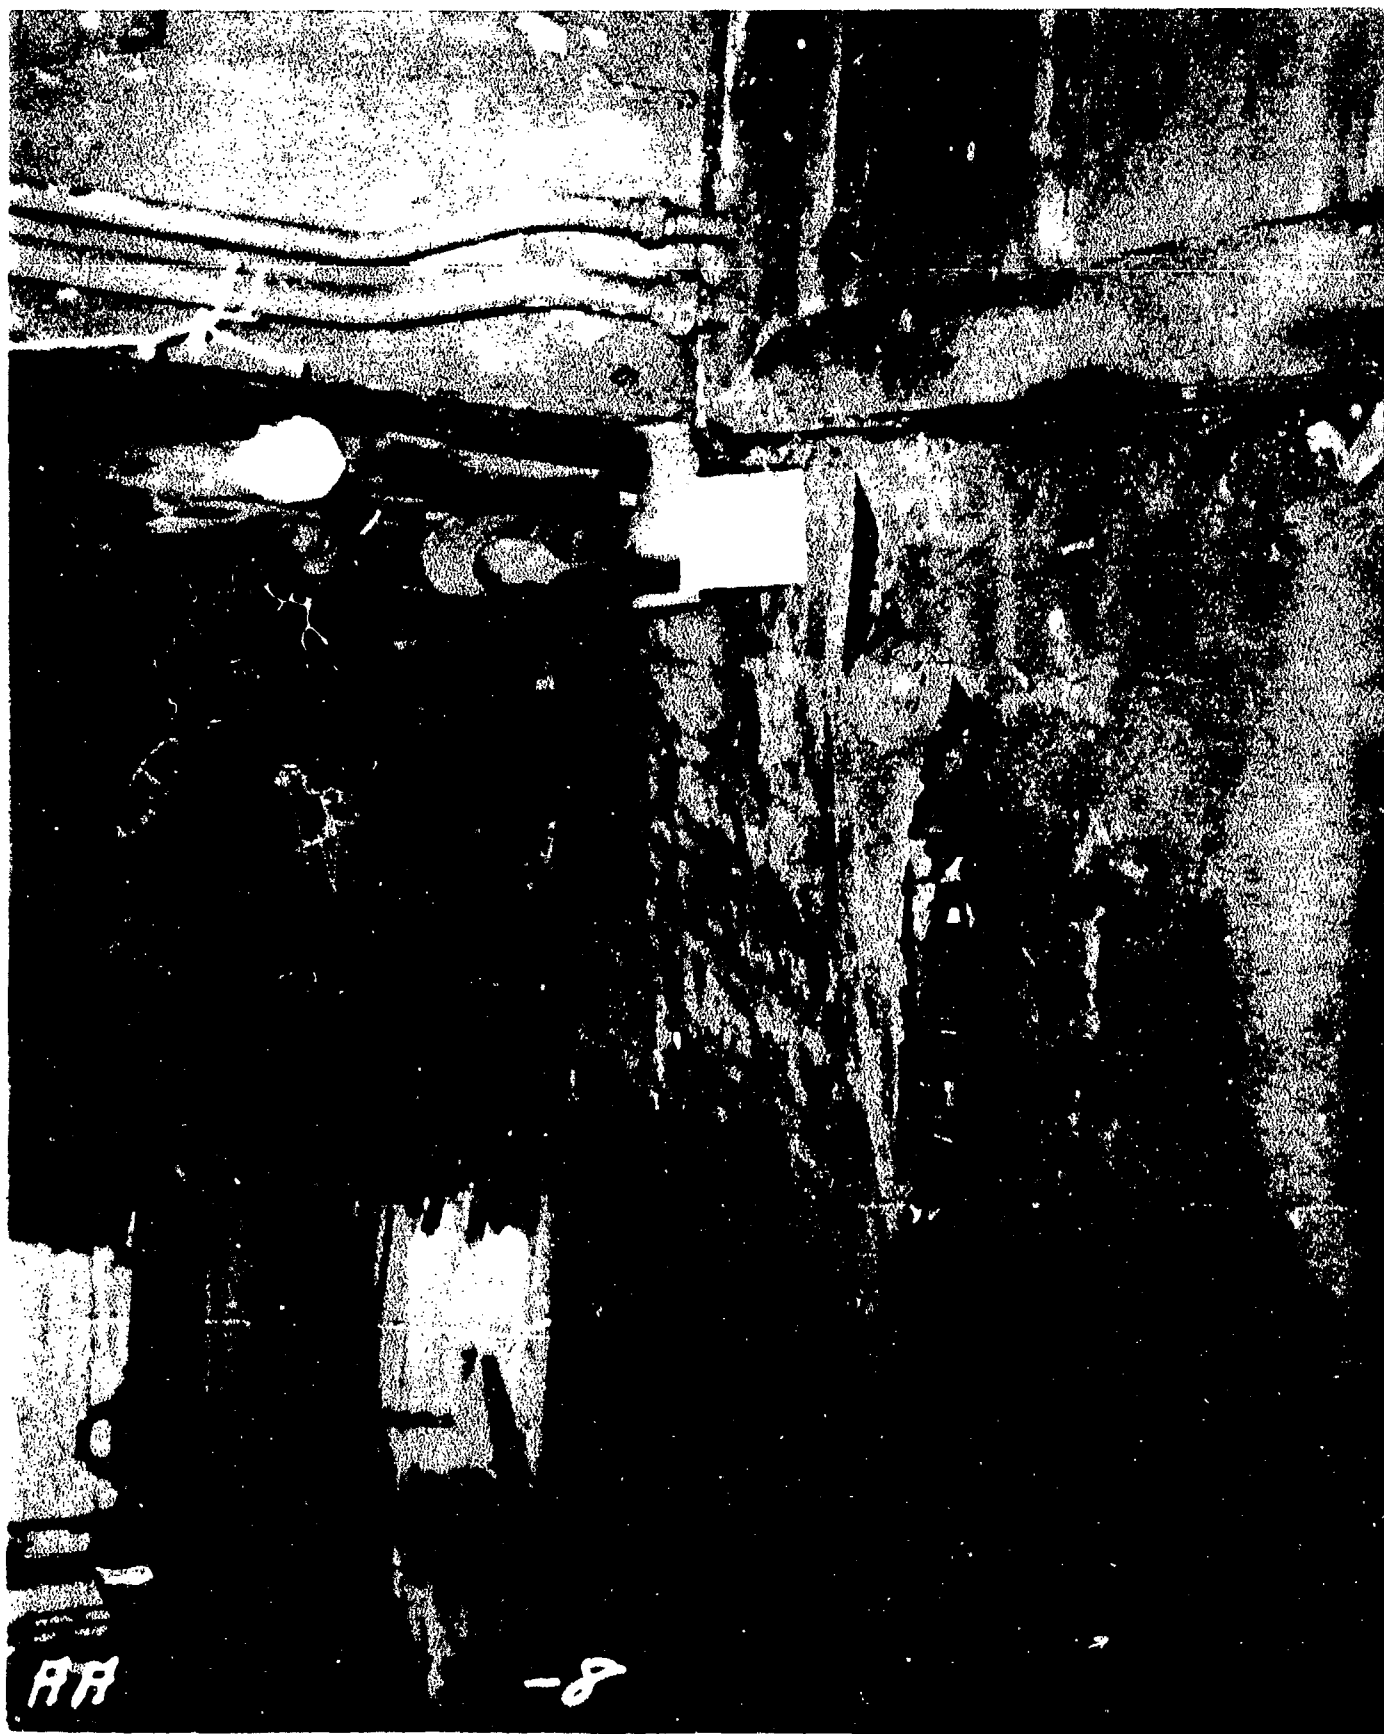
AA-CR-68-1754-8. Close-up of starboard forward portion of main deck, well deck area, looking to port, showing tear of lighter plating along stringer strake, deck dishing and damage to deck house bulkhead 61.

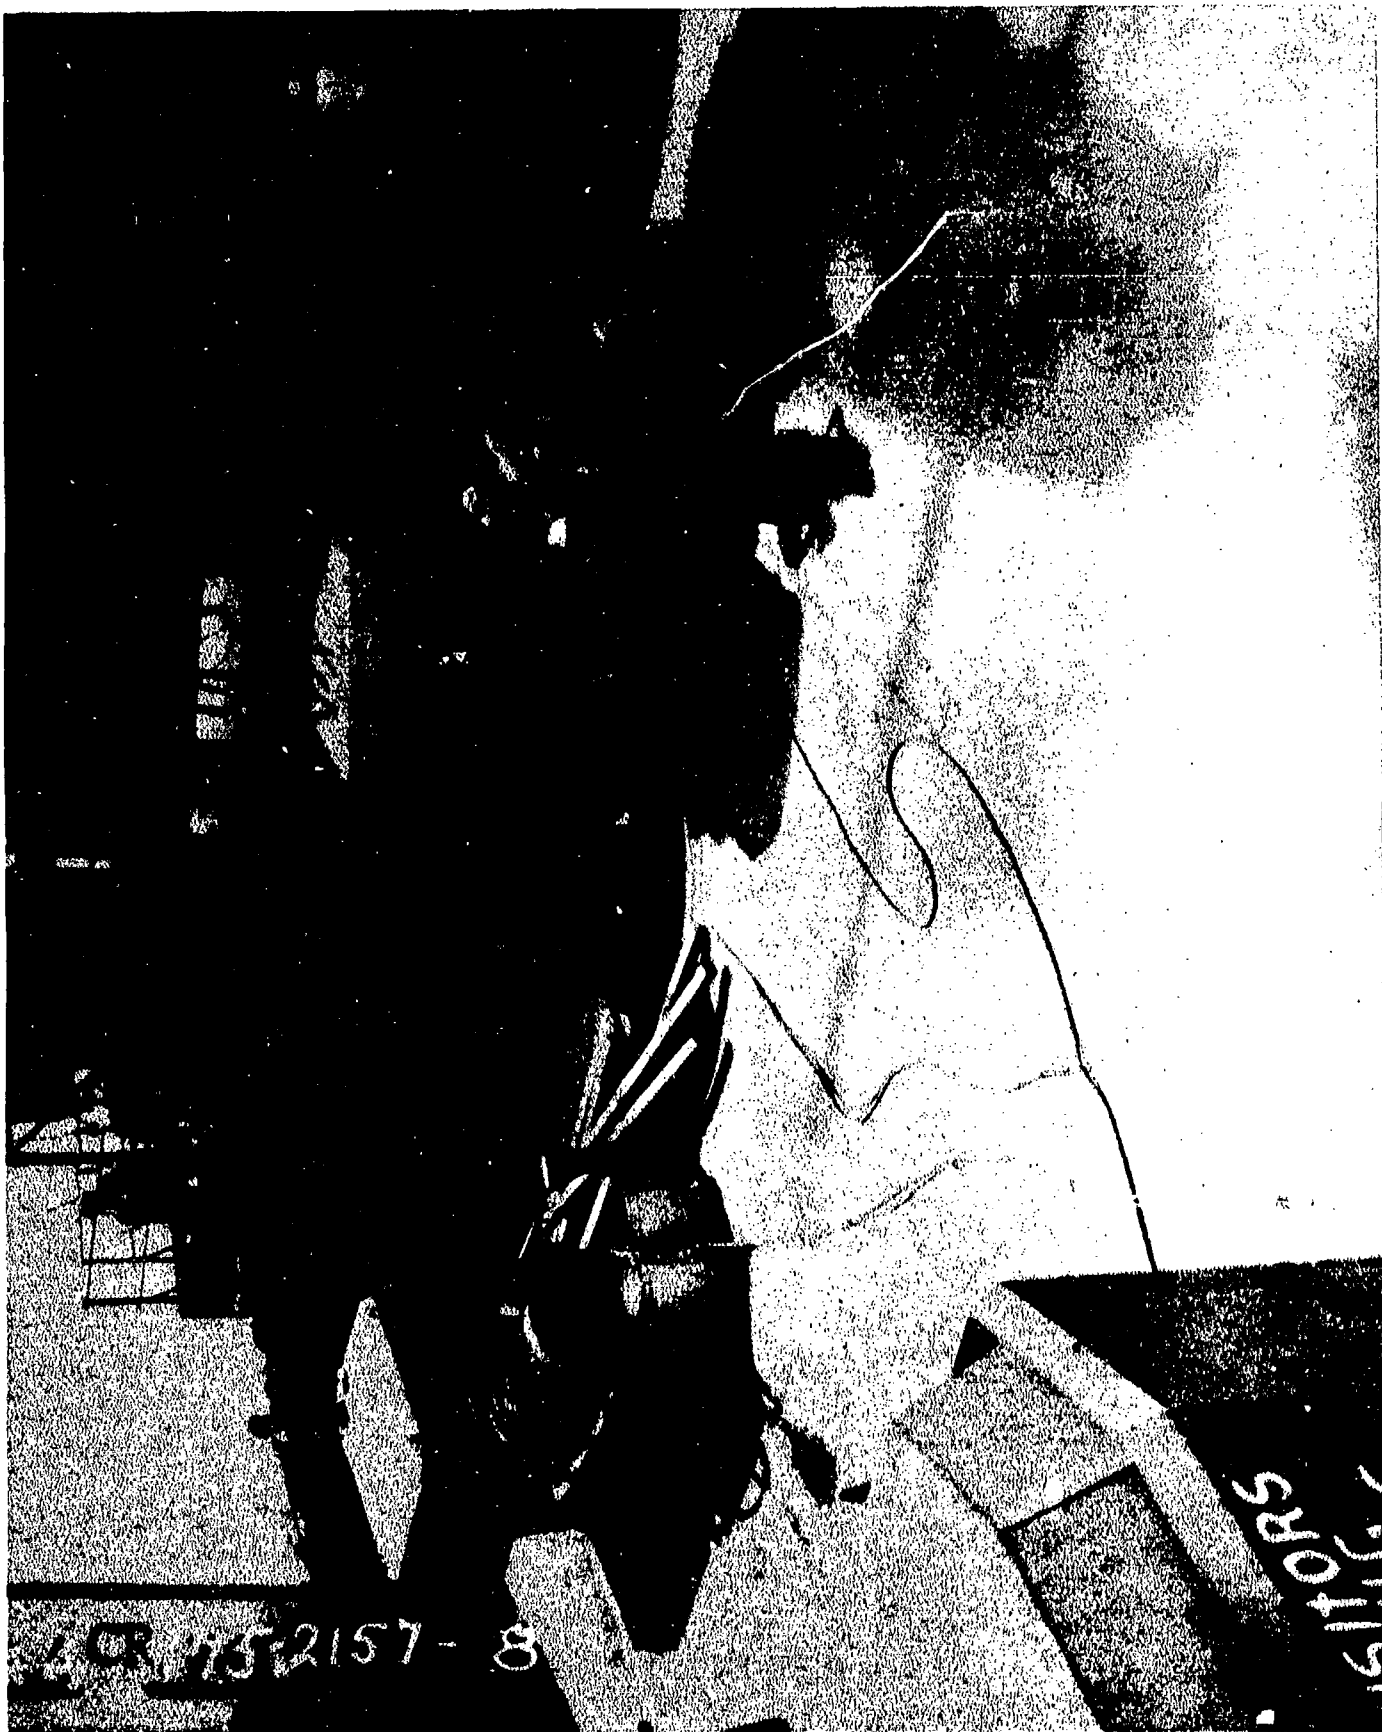
AA-CR-175-2157-8. Main deck, well deck area, looking forward and to port, showing deck dishing and damage to forward stack cape and rear of deck house.

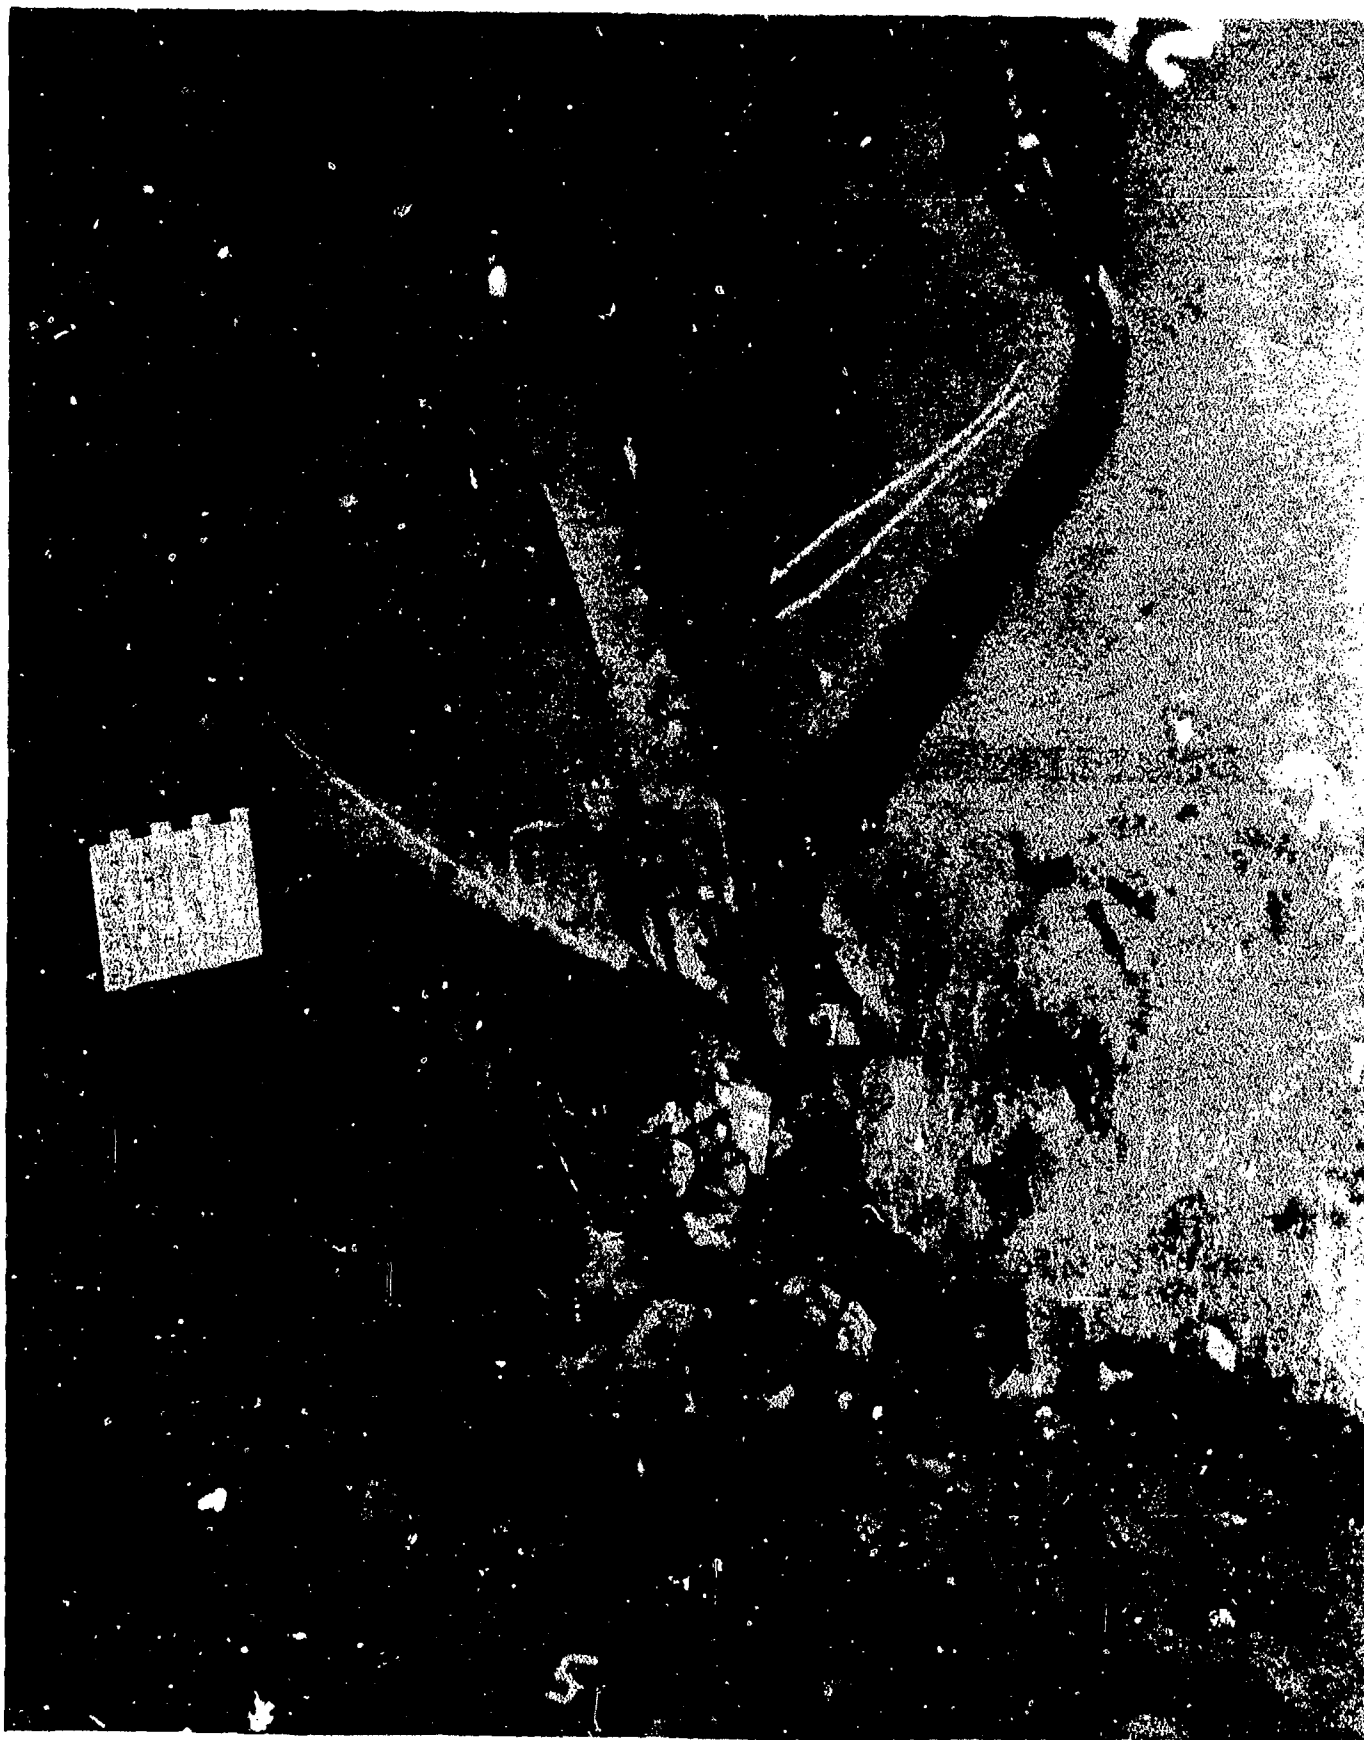
AA-CR-68-1767-5. Looking aft on main deck in well deck area showing ruptures at frame 62 1/2 in way of port ventilation trunk and hatch.

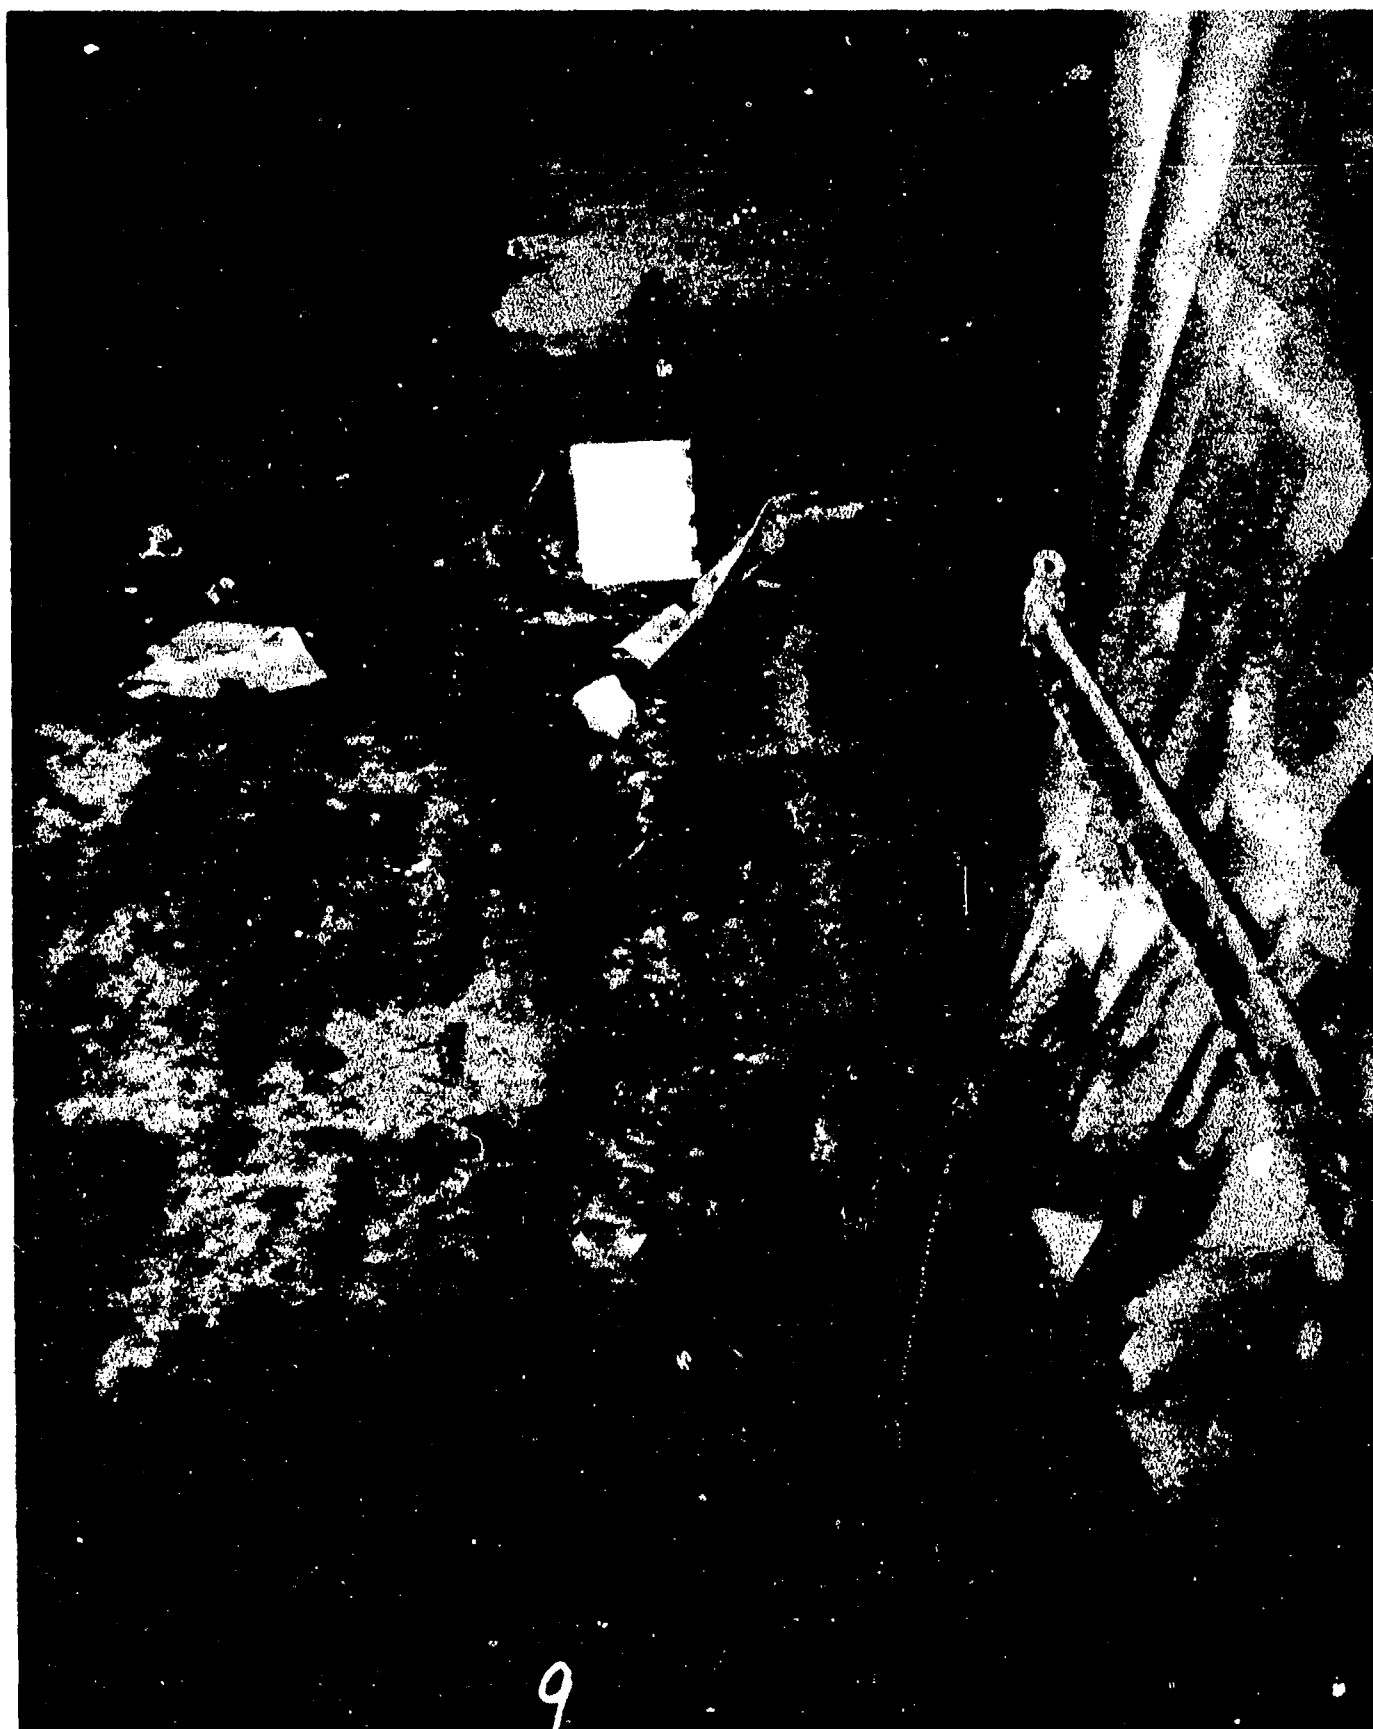
AA-CR-68-1754-9. Failure of main deck plating-butt at frame 62 1/2 to starboard of centerline hatch in well deck area.

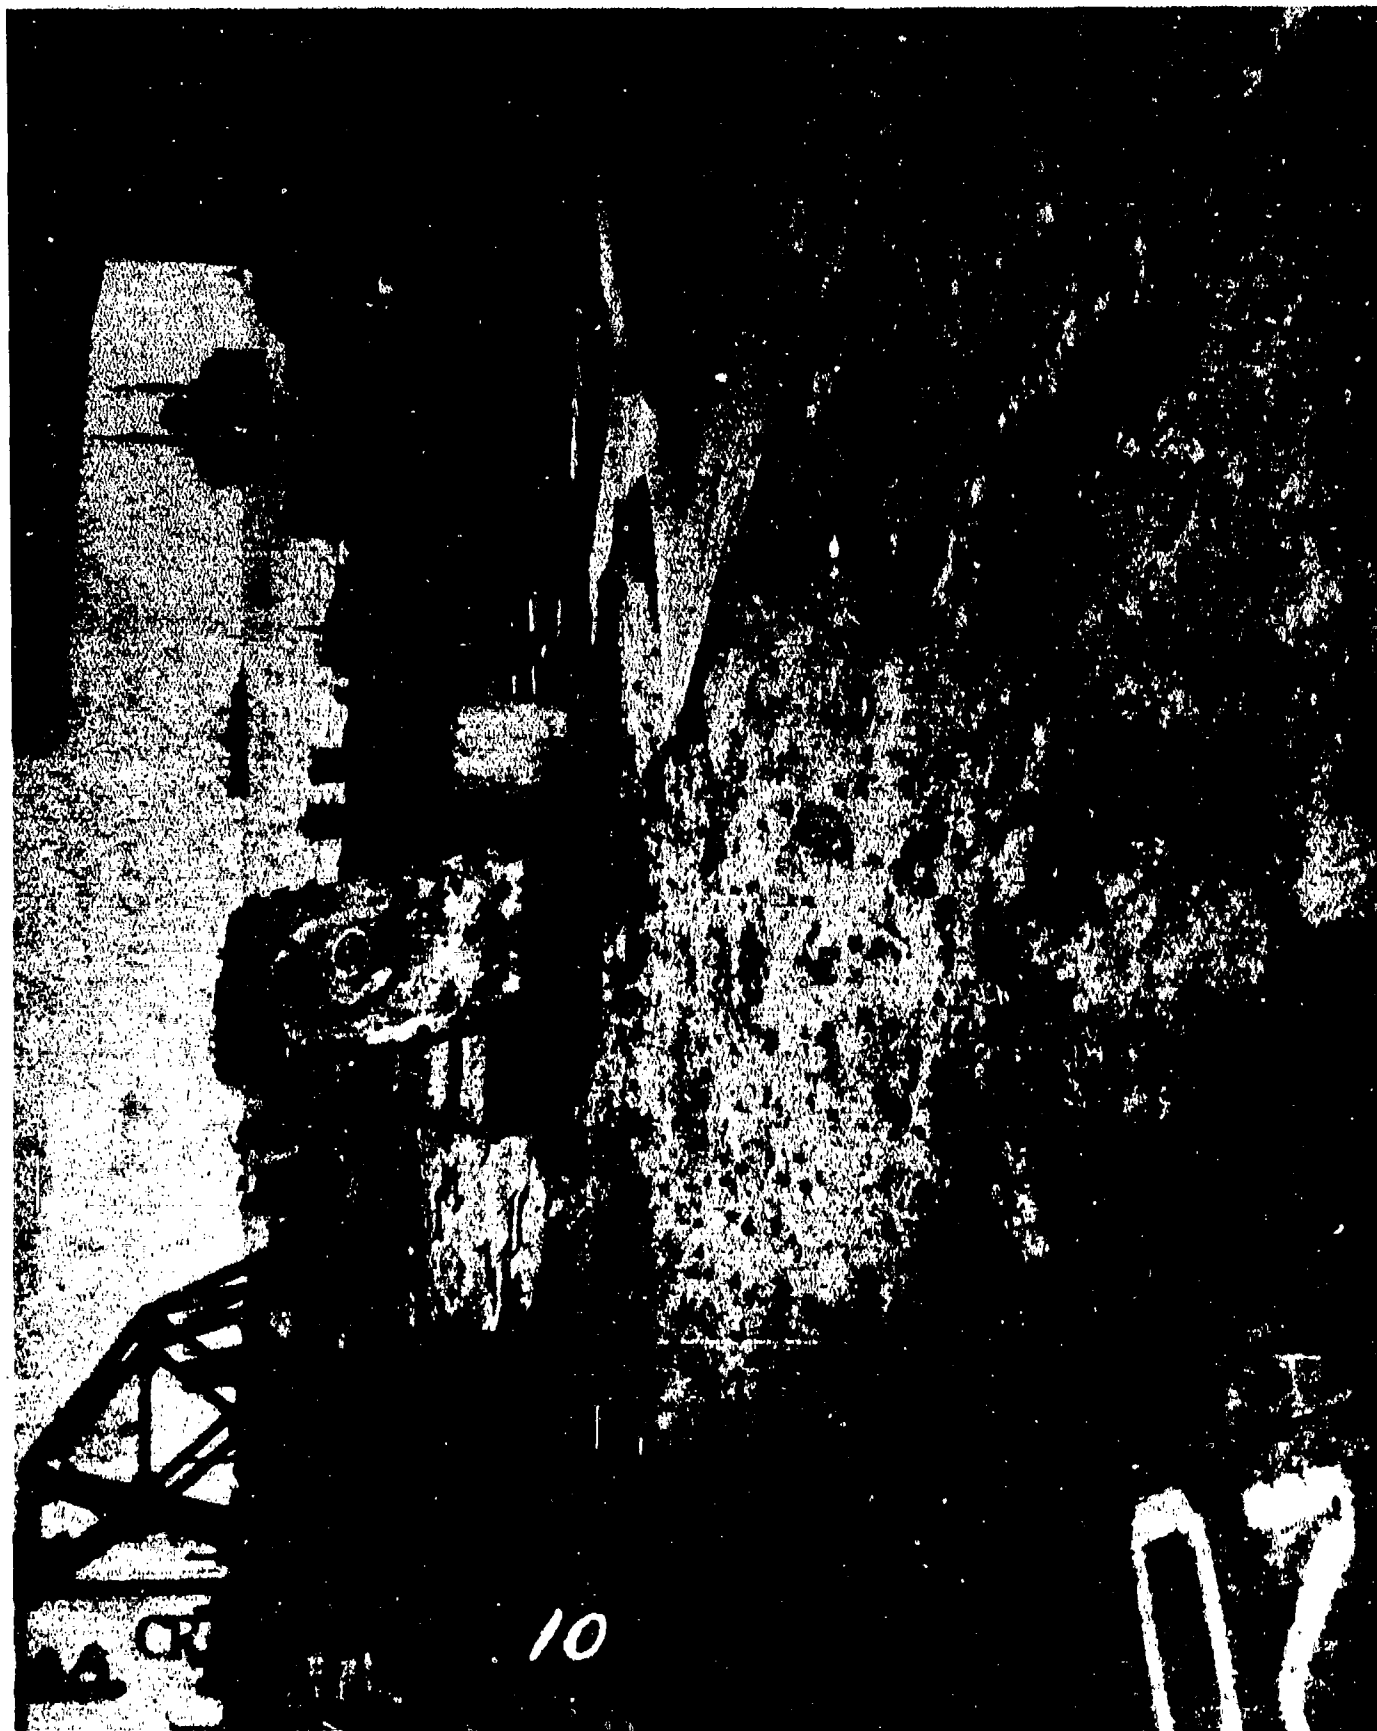
AA-CR-175-2158-10. Main deck, starboard, looking from frame 120, after removal of burned Army equipment showing damage to wood decking; also the downward deflection of the deck further aft is noticeable.
